# **CITY OF SUNNY ISLES BEACH**

## **Feasibility Study Summary of a Bridge to Link a Pedestrian/Bicycle Greenway**

**Extension of North Bay Road from 172<sup>nd</sup> to 174<sup>th</sup> Street  
City of Sunny Isles Beach**

CGA Project No. 04-4567  
September 2004

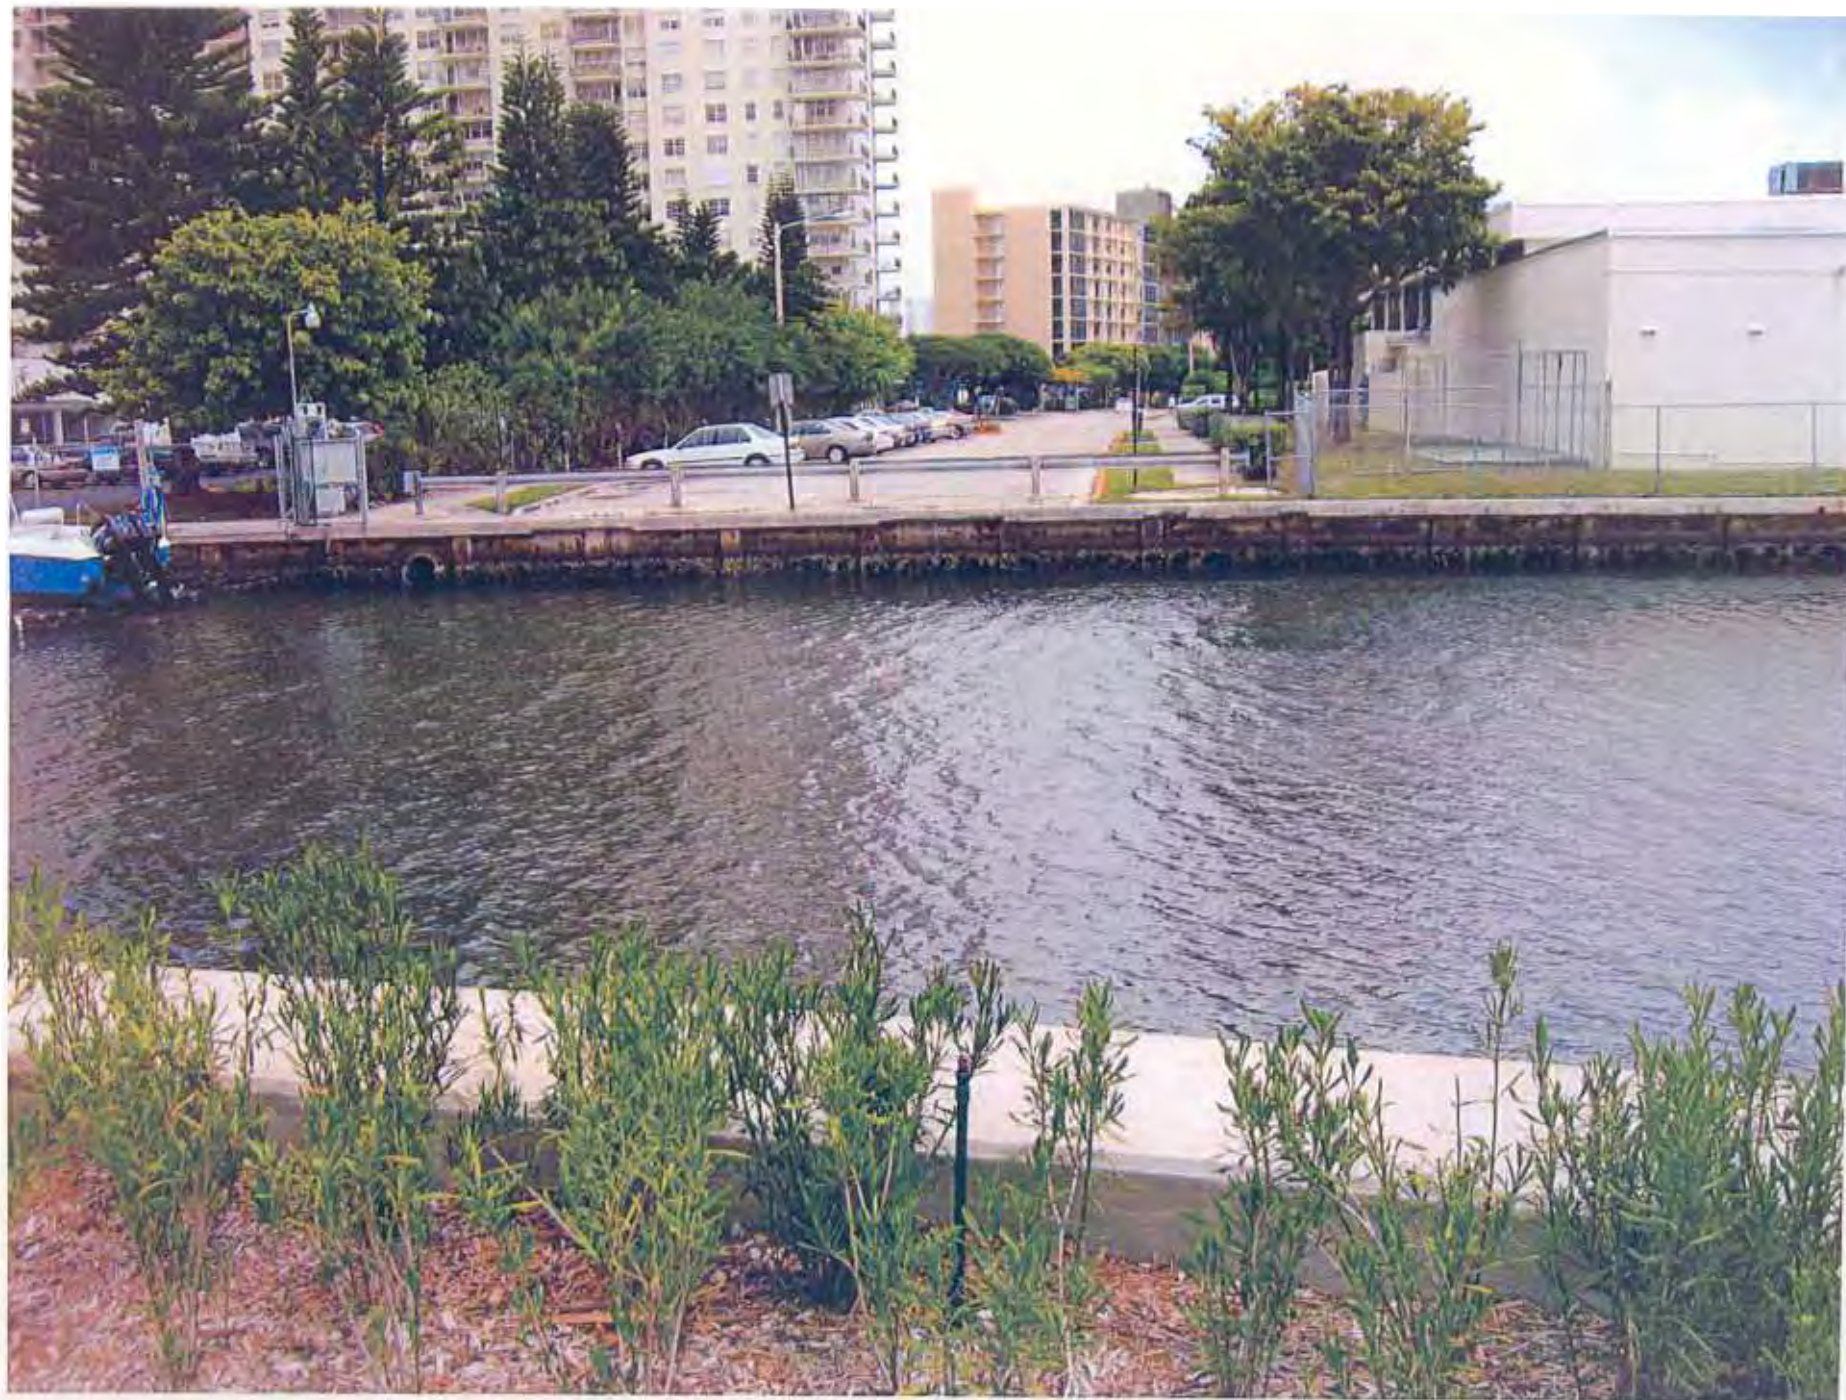
Figure 1

Looking North at North Bay Road

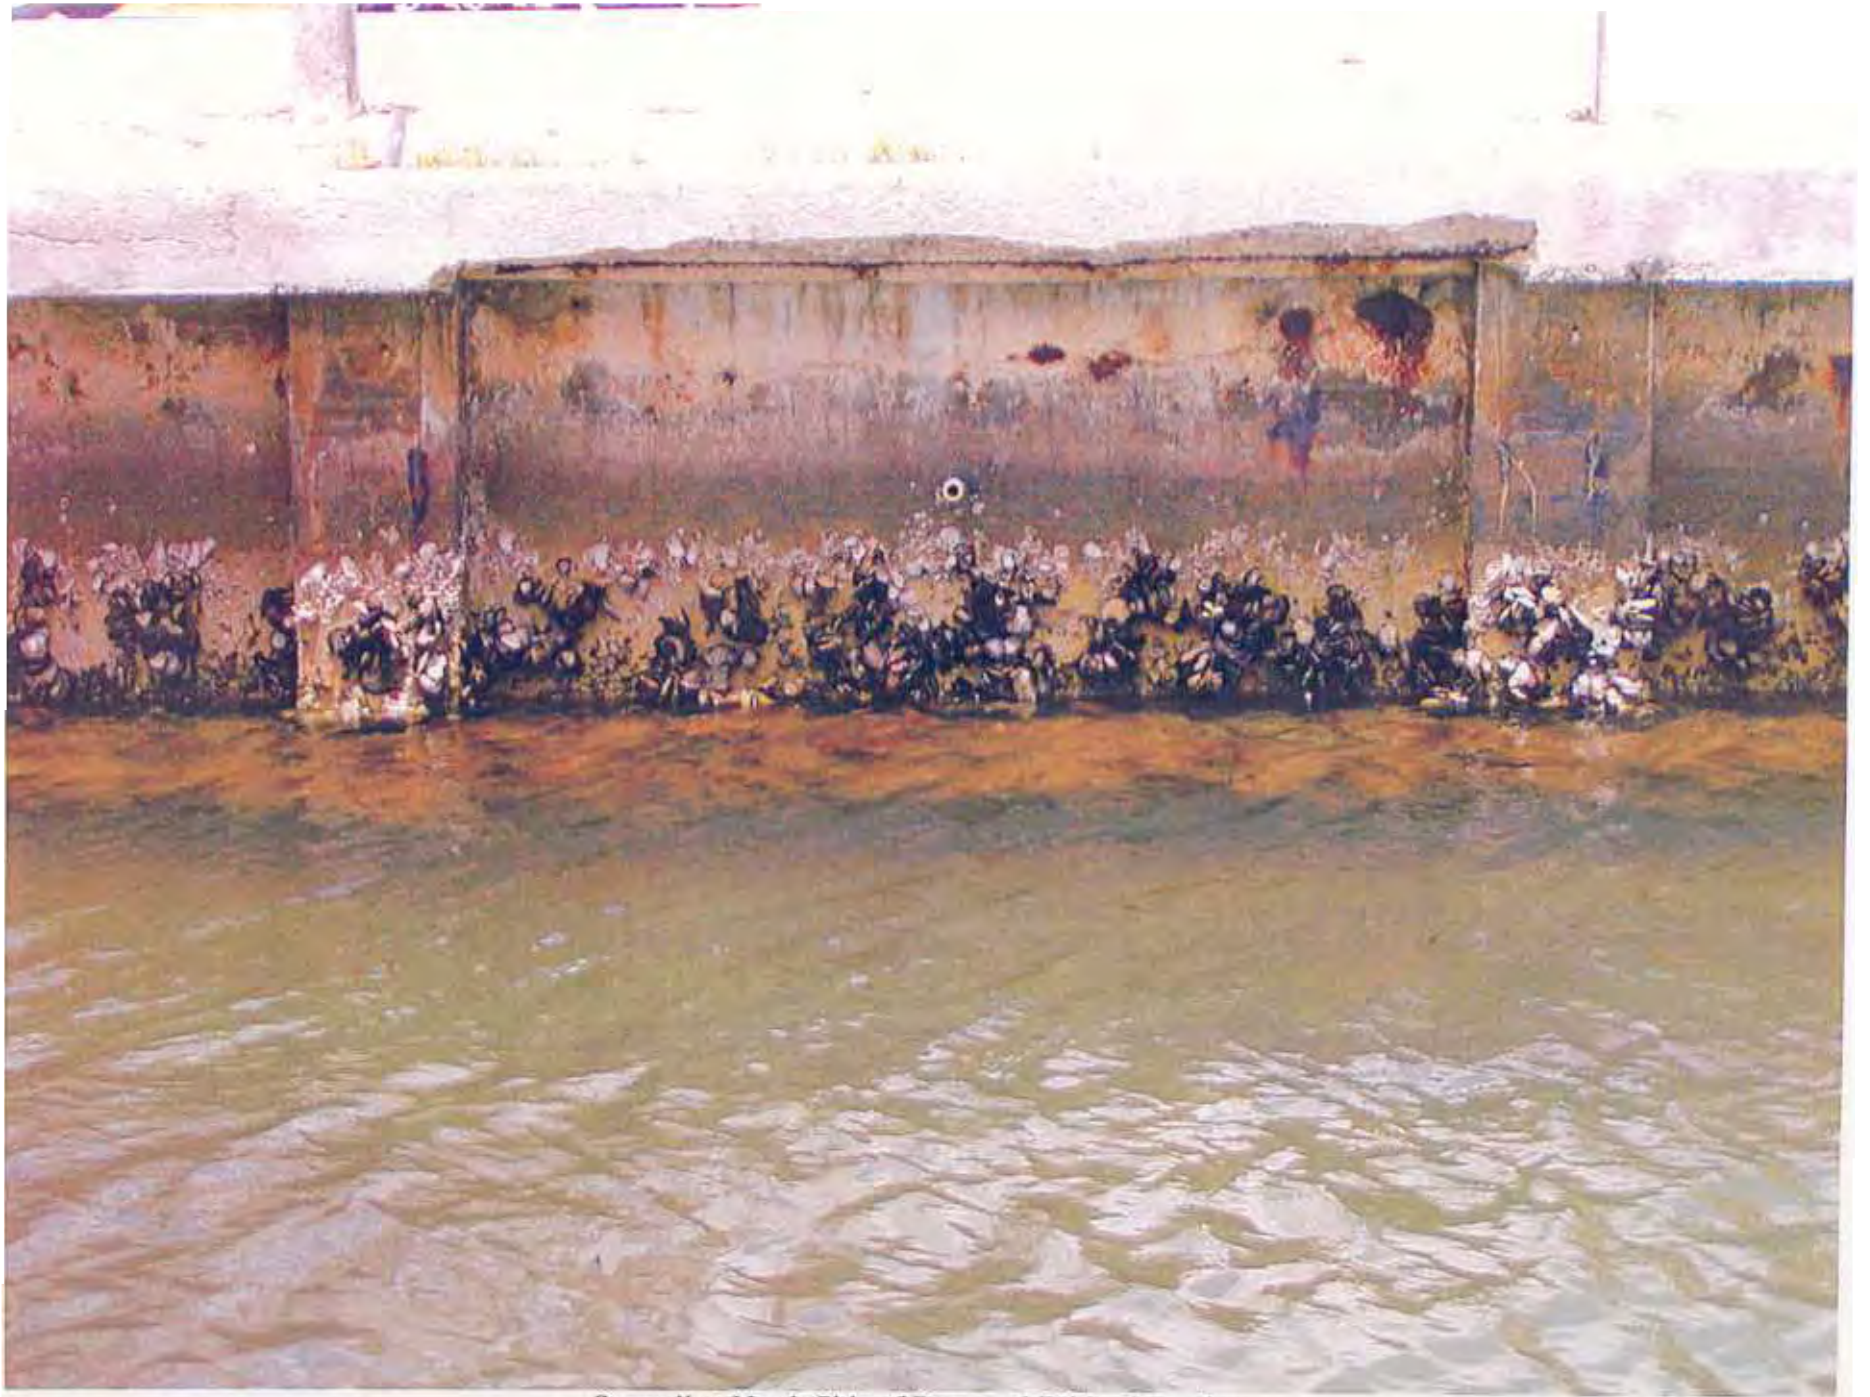
Figure 2

Seawall at North Side of Proposed Bridge Location

The water, at least several feet deep at the bulkhead, was quite turbid. No coral, seagrasses or hardbottom communities were observed in the submerged lands along the north shoreline. The bulkhead had a narrow fringe of algal material and colonies of mollusks along the mean water line. See Figure 2. The bulkhead continued to the east and west of the proposed bridge location.

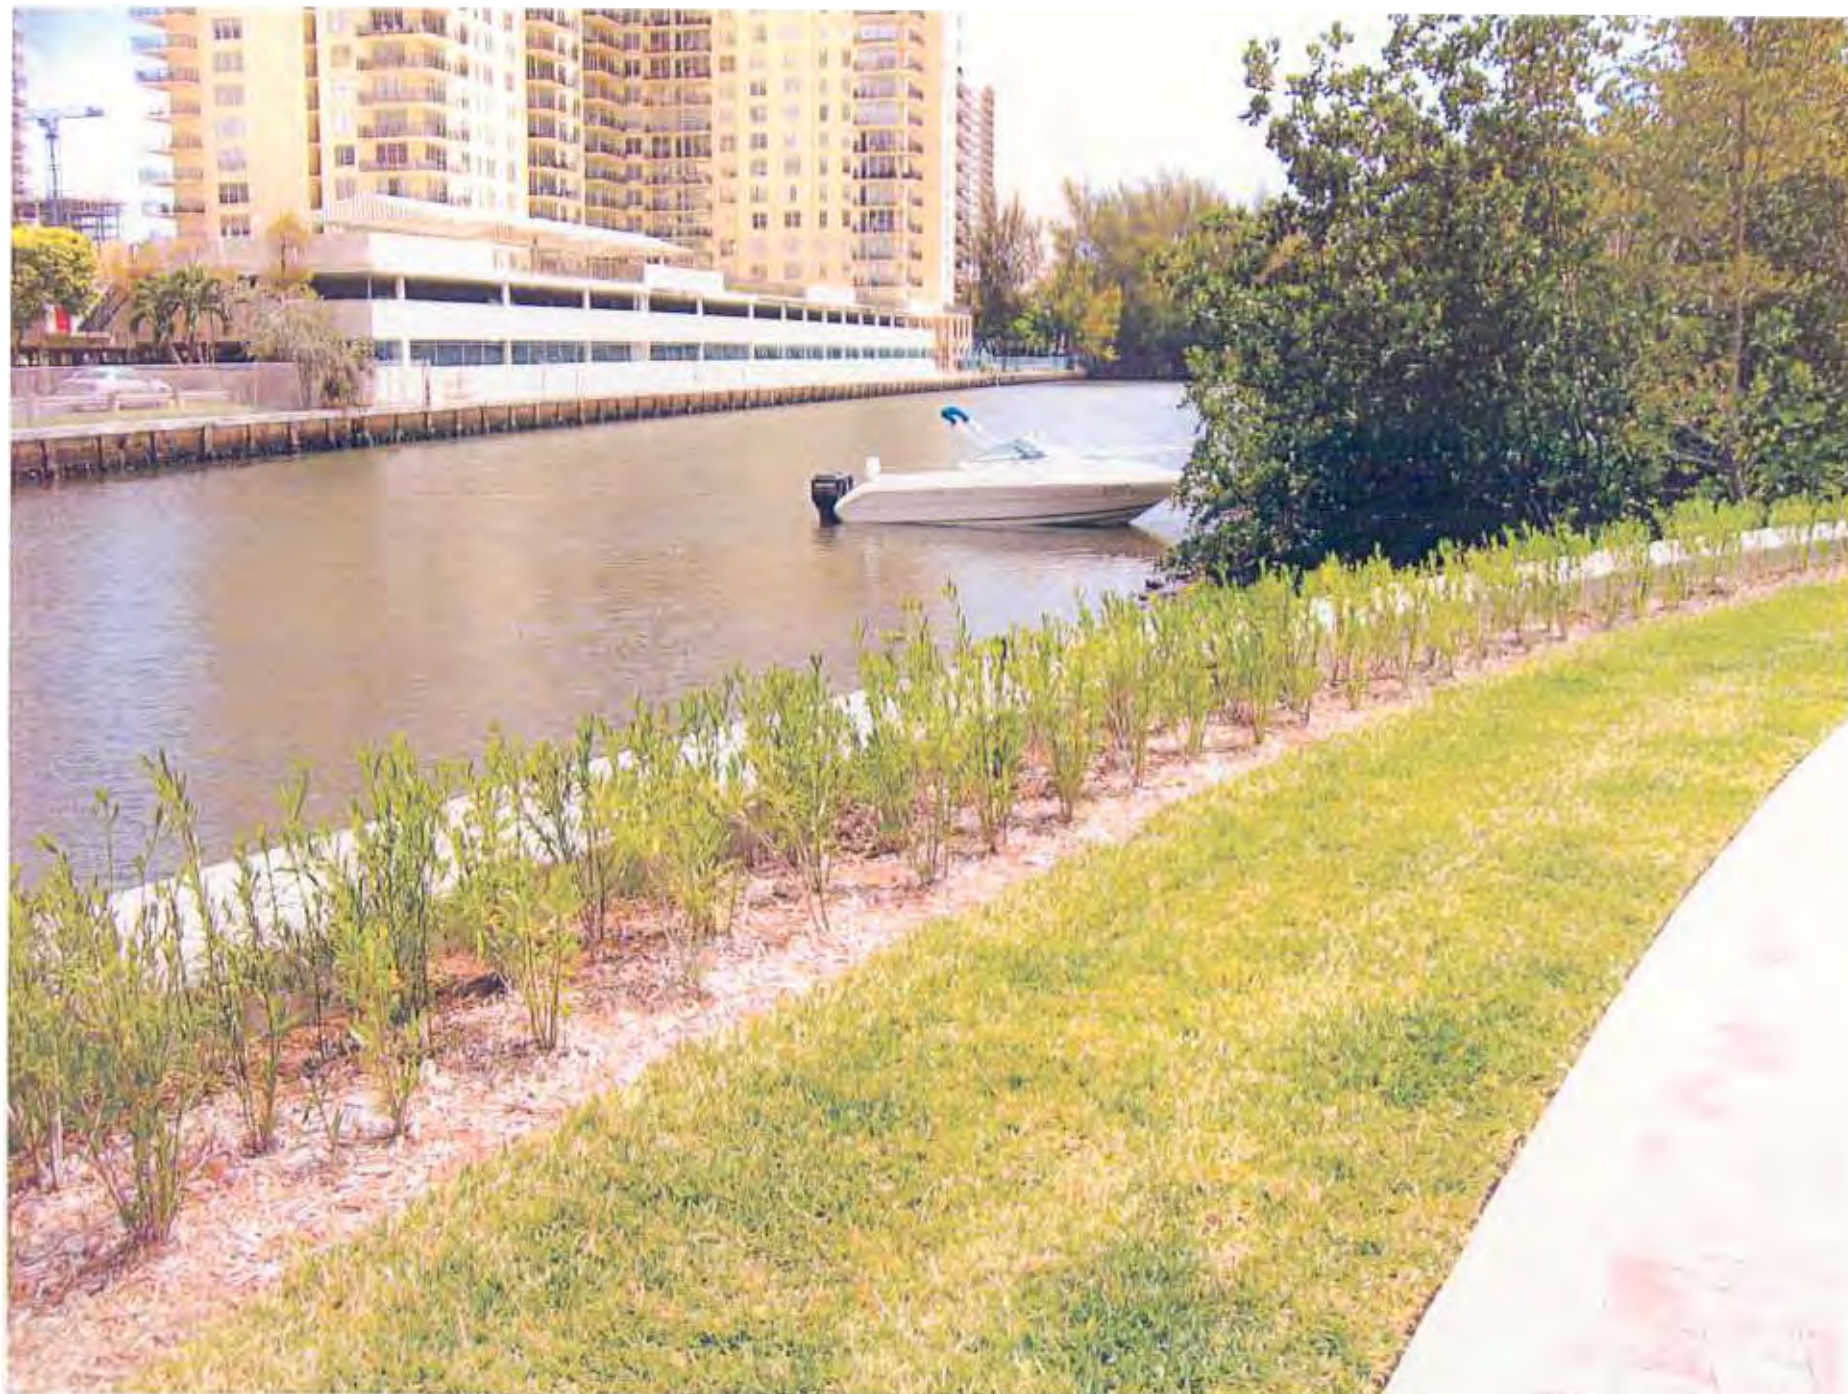
Figure 4

Vegetative Strip Along Seawall on South Side of Canal Looking East

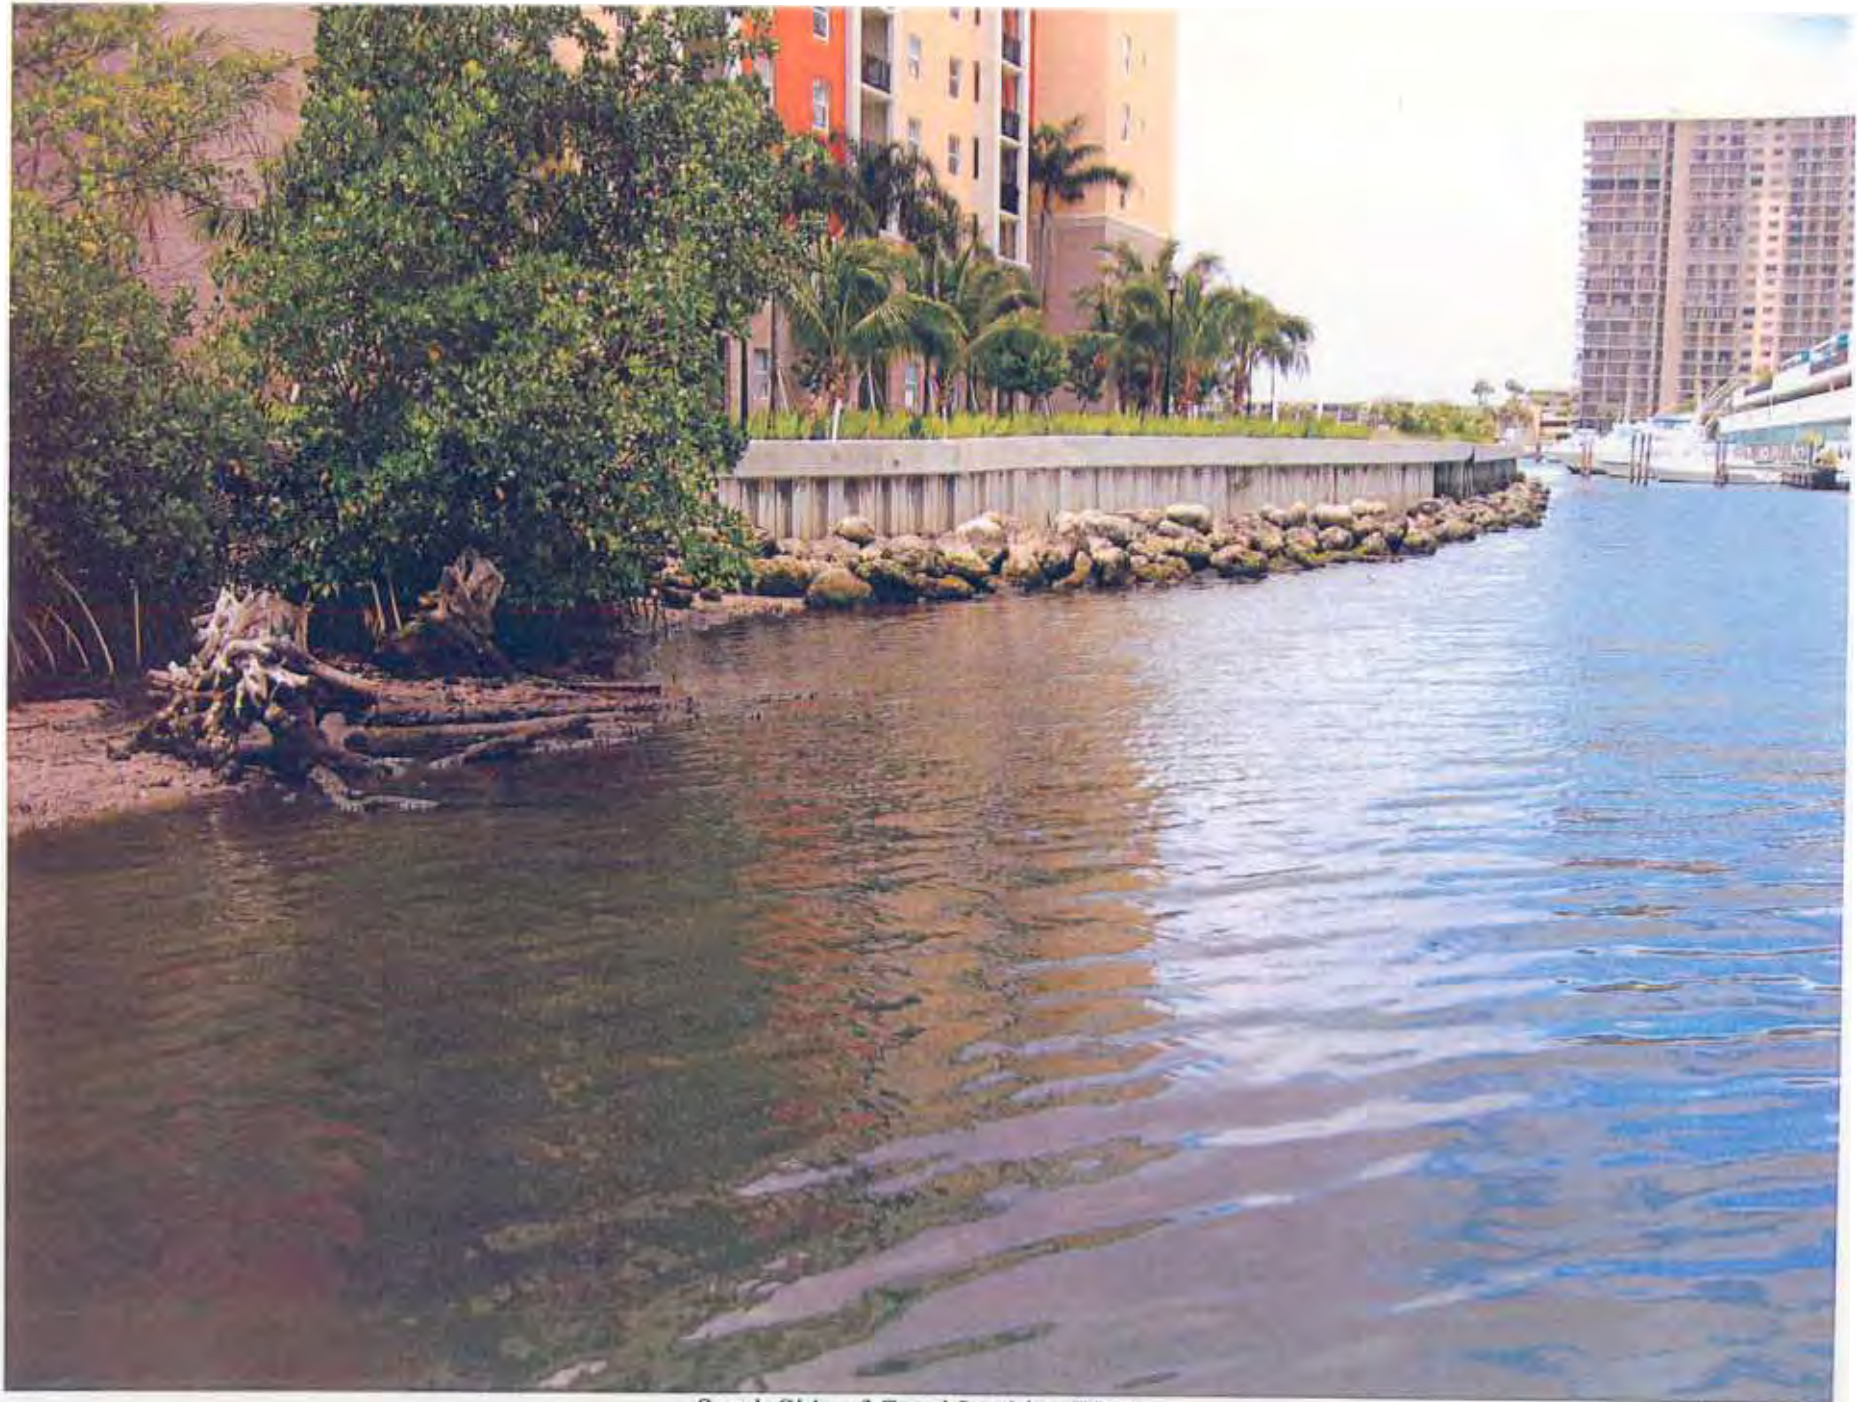
Figure 5

South Side of Canal Looking West

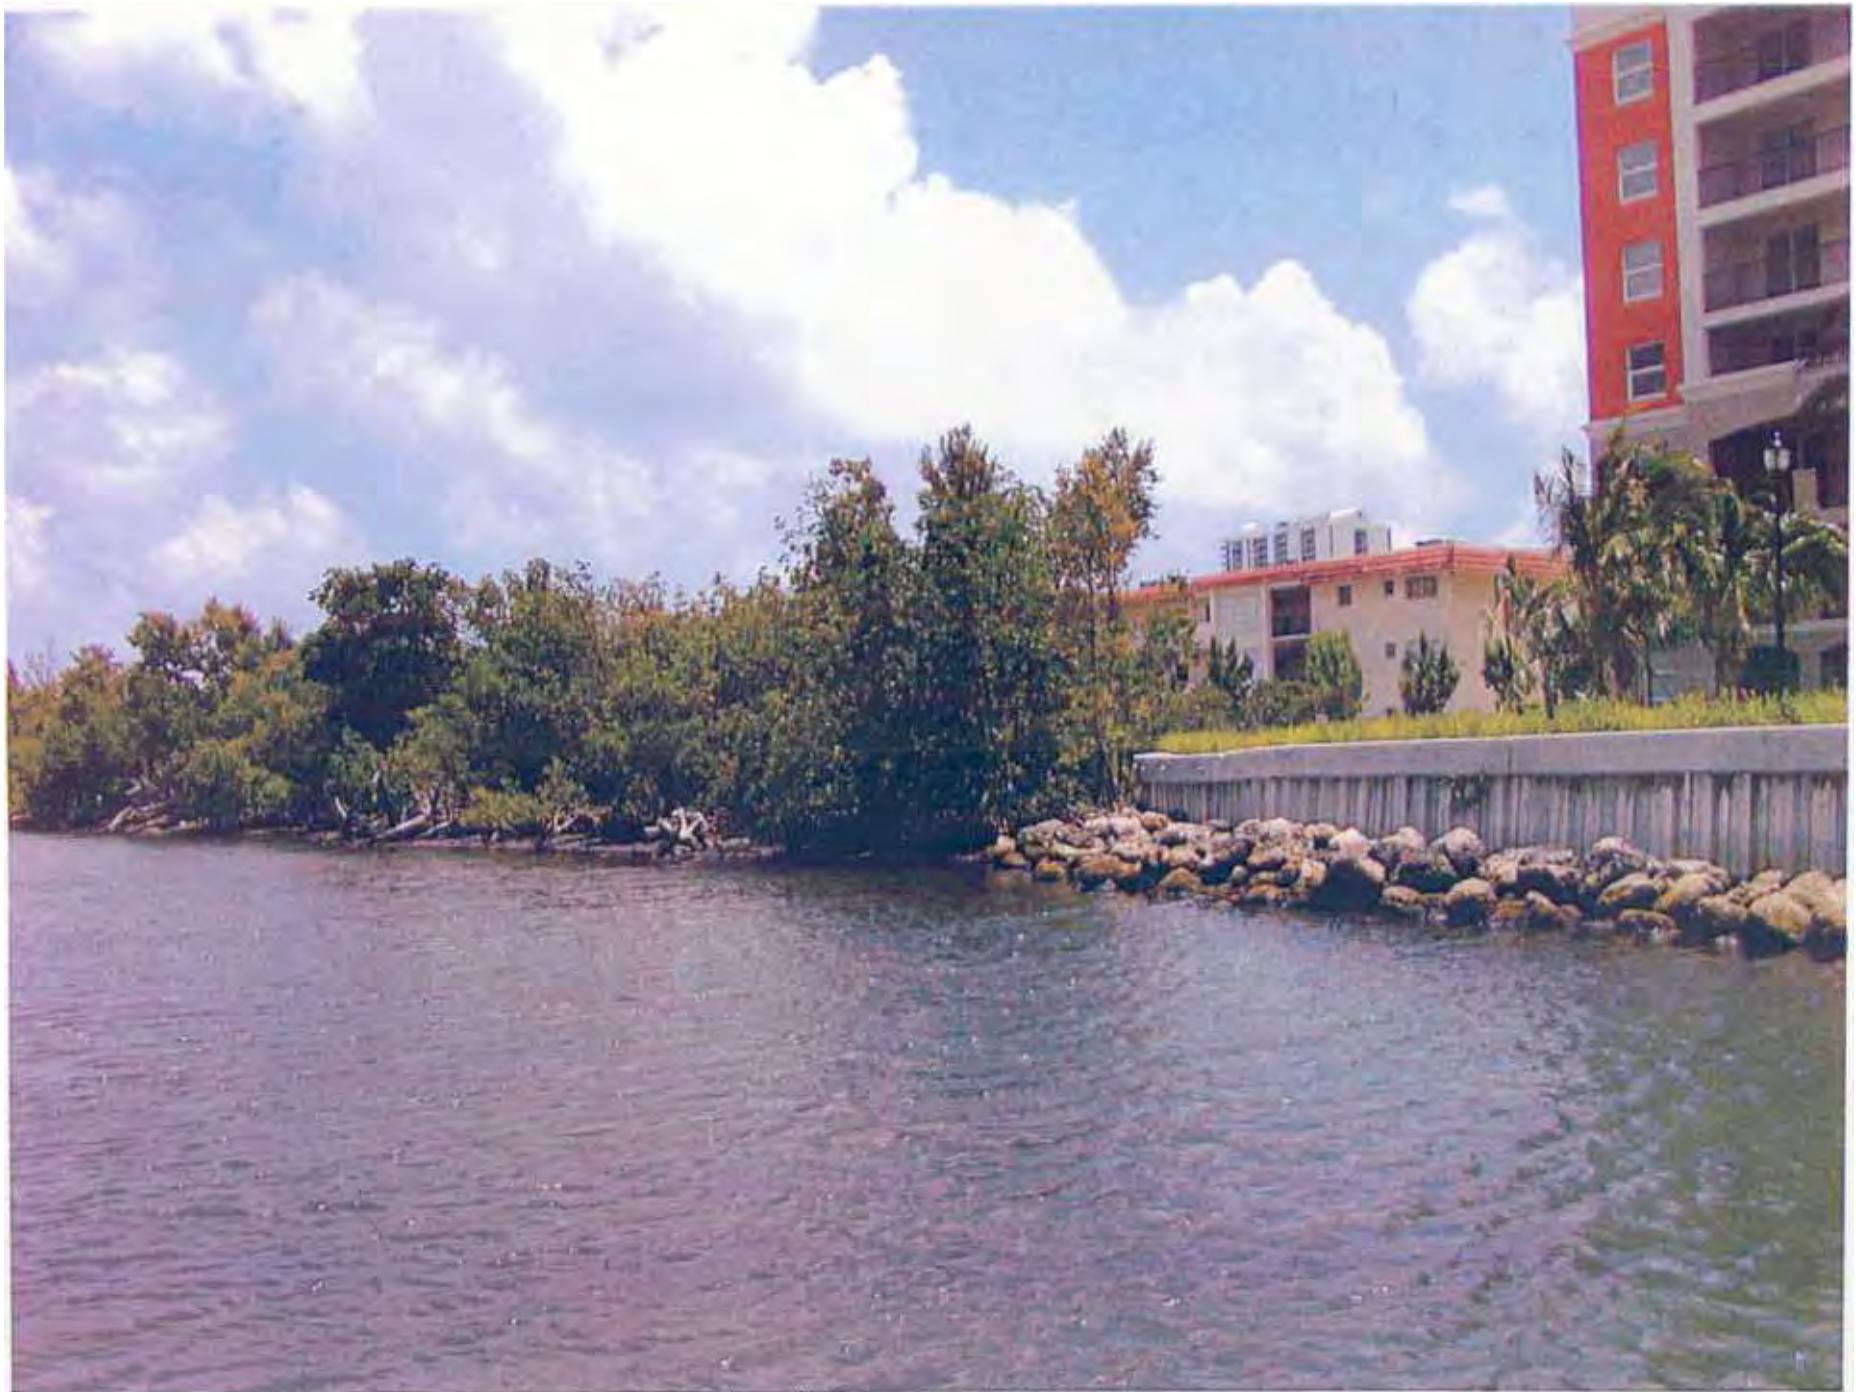
Figure 6

Looking ESE From Canal at Impact Area

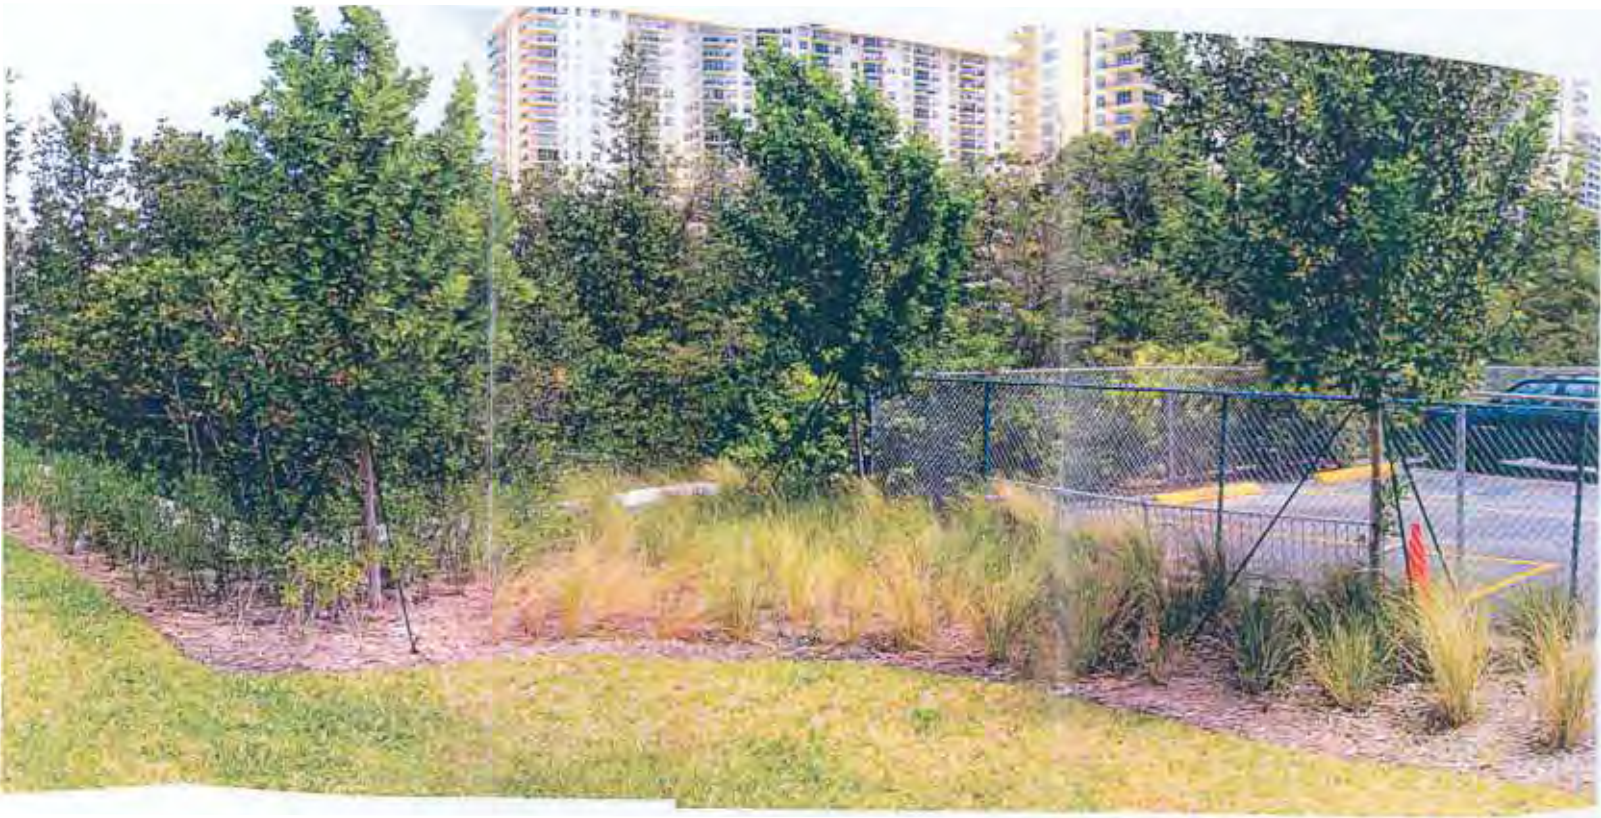
Figure 7

Proposed Bridge Location

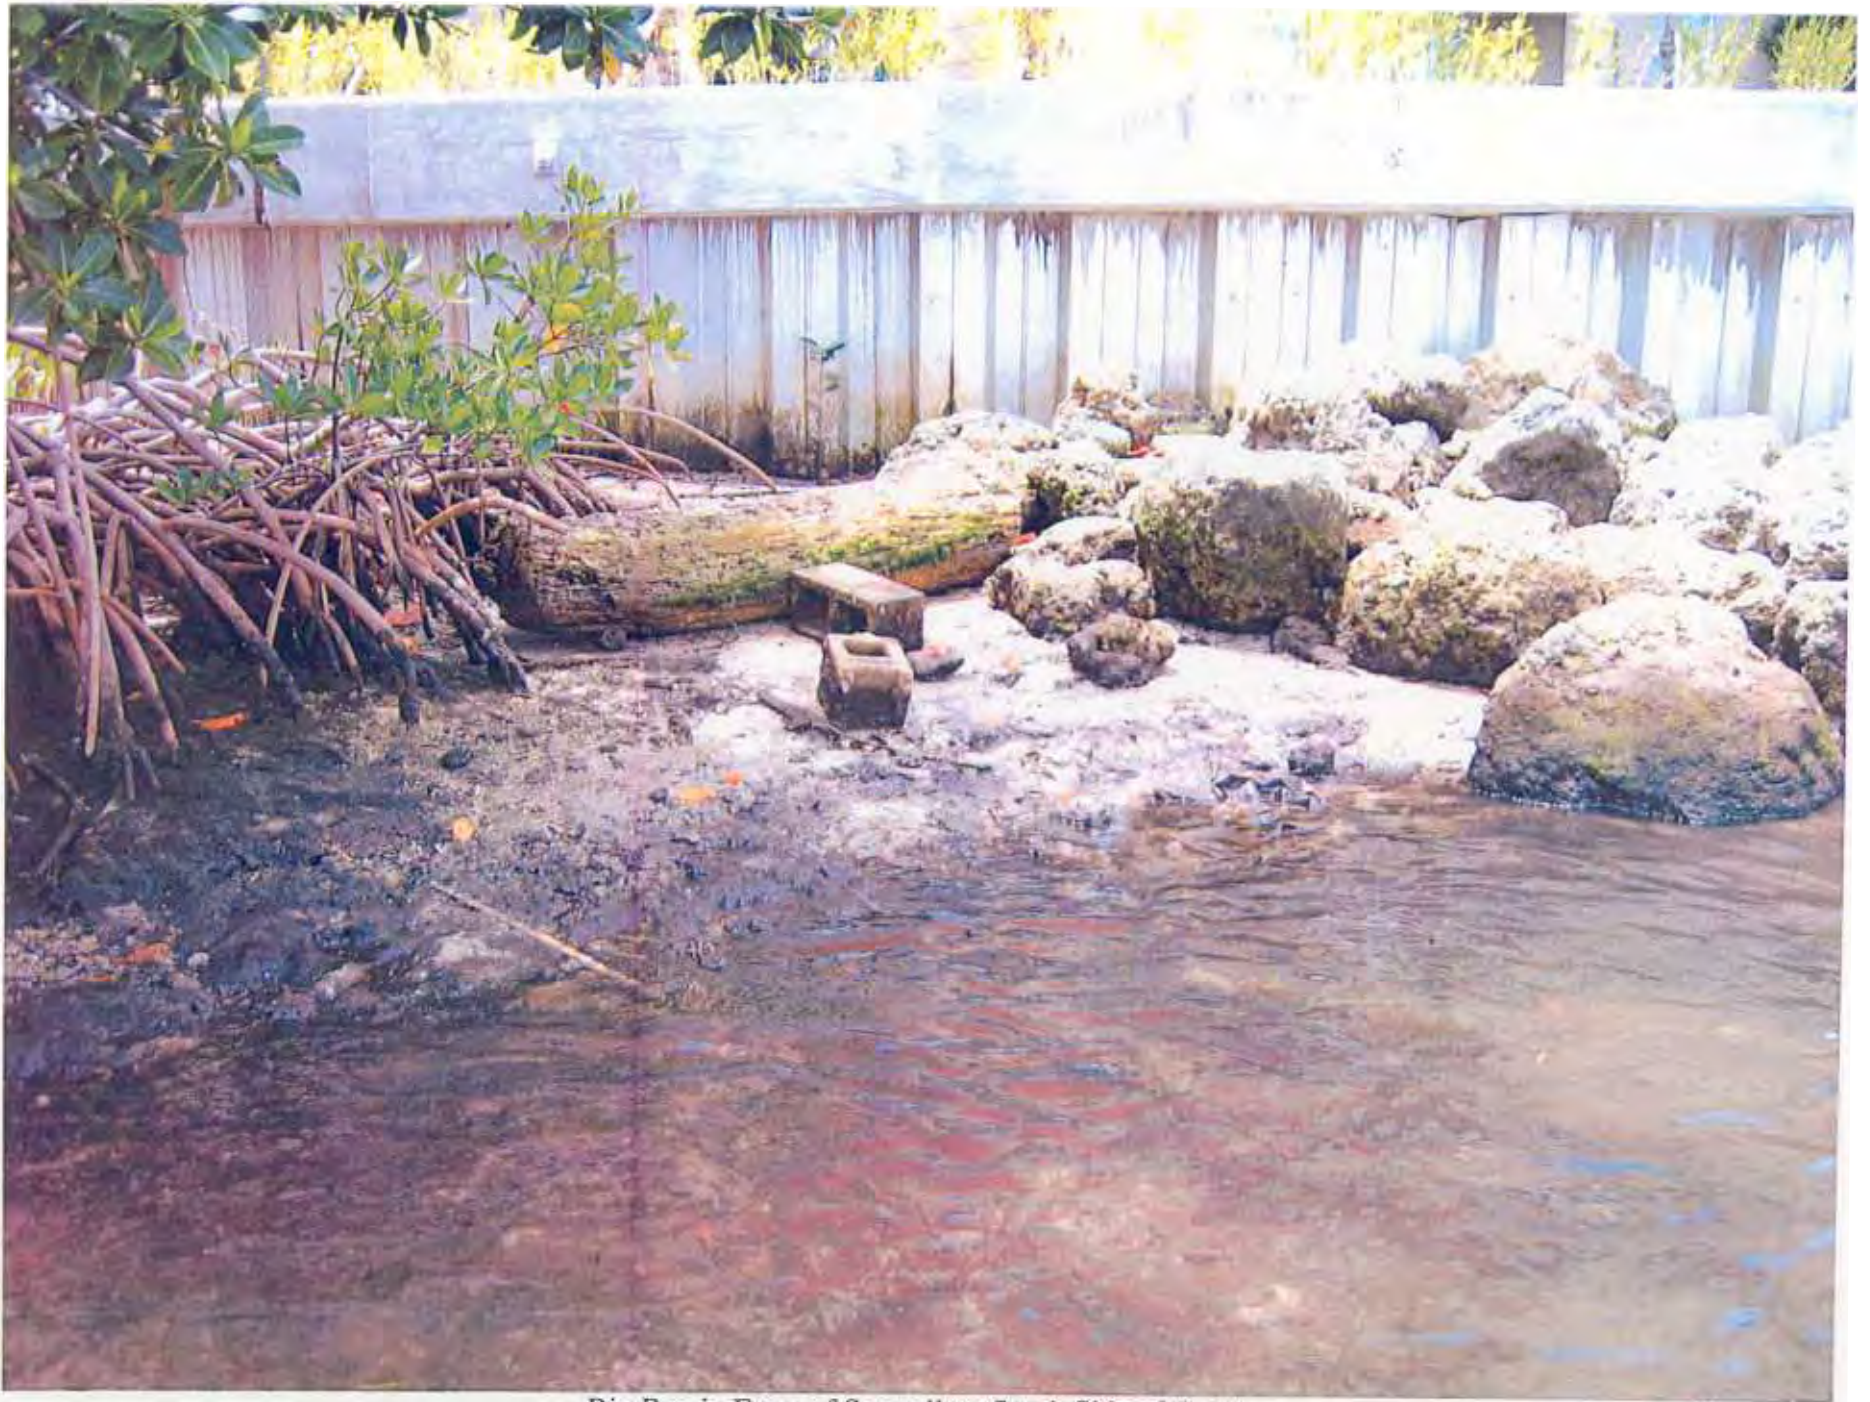
Figure 8

Rip Rap in Front of Seawall on South Side of Canal

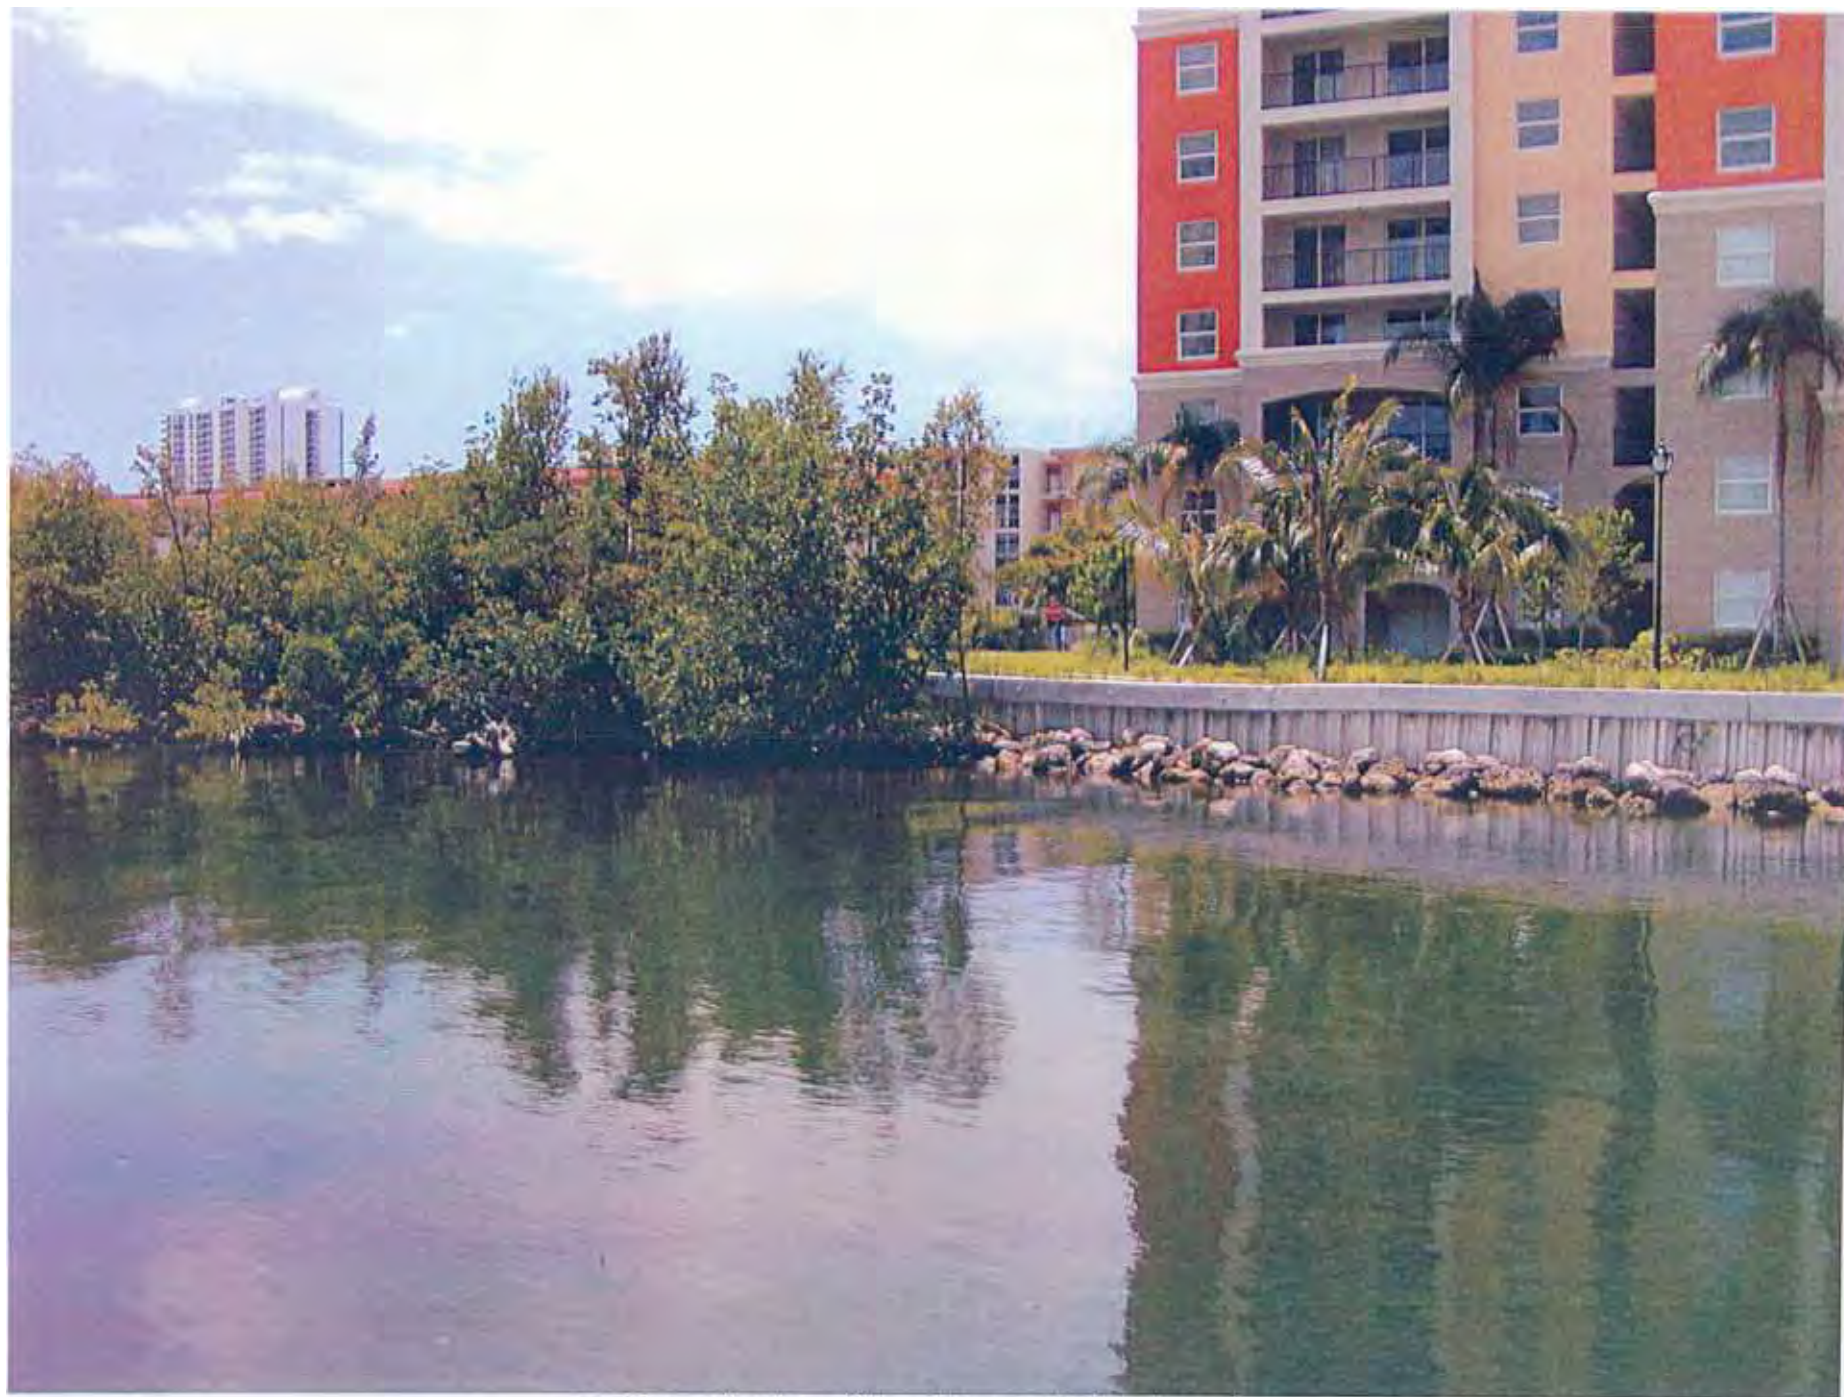
Figure 9

Looking at Southern Side of Proposed Bridge Location

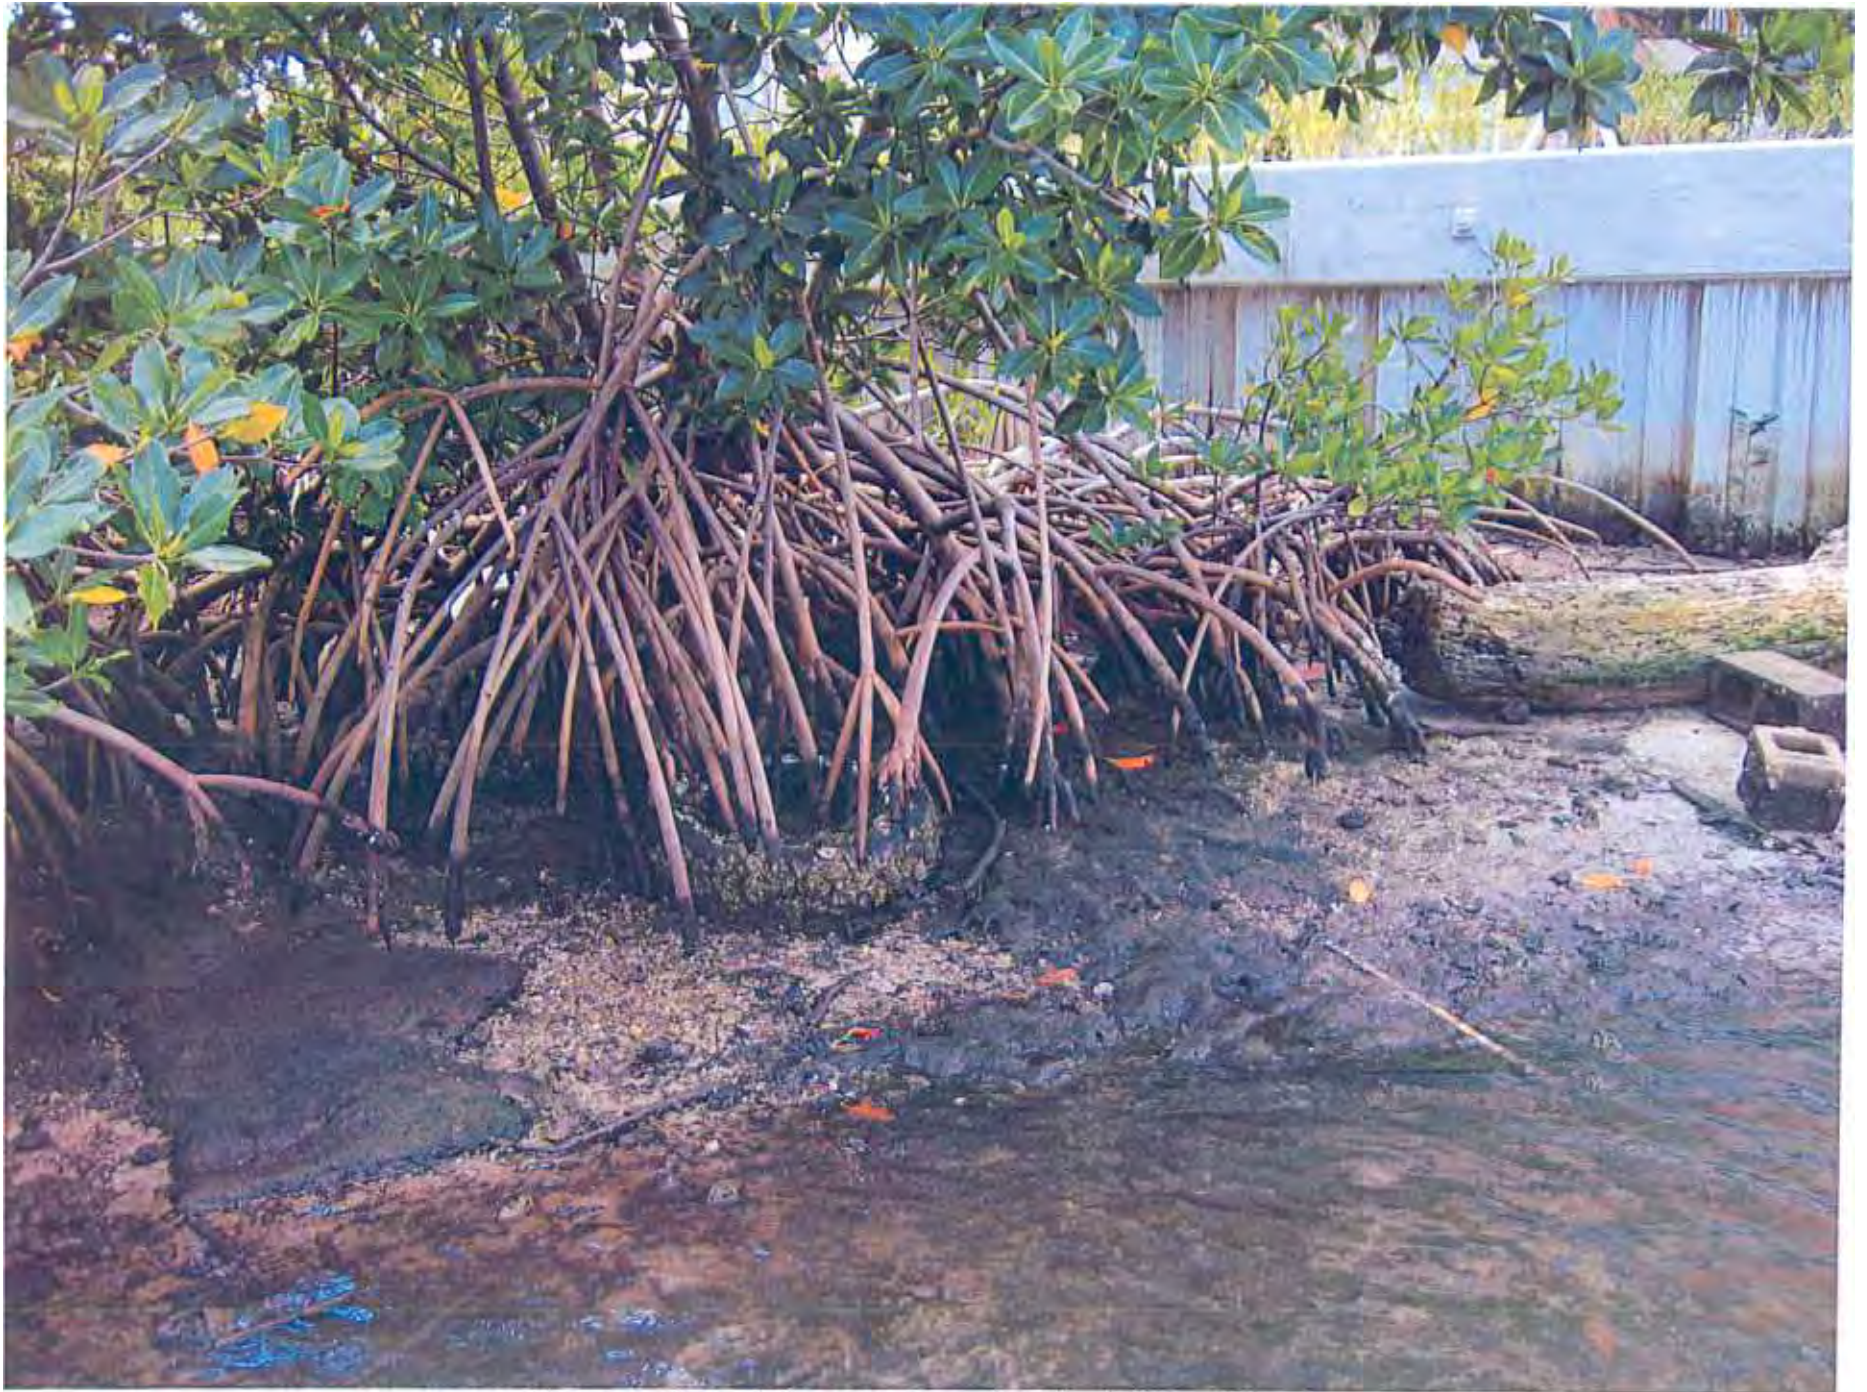
Figure 10

Mangrove Roots Adjacent to Seawall on South Side of Canal

East of the riprap the immediate shoreline is unimproved, consisting of a sandy/mucky substrate vegetated with mangroves. Red Mangroves (*Rhizophora mangle*) dominate closest to the water line with the Black Mangrove (*Avicennia germinans*) and White Mangrove (*Laguncularia racemosa*) dominating closer to the upland development. See Figure 8. Dead tree stumps and washed-up detritus litter the unimproved area of the south shoreline. Sand Cordgrass (*Spartina bakeri*), Beggarticks/Romerillo (*Bidens alba* var. *radiata*), and Ragweed (*Ambrosia artemisiifolia*) plants can be found at the immediate interface of the sheet pile and mangrove fringe near the parking area.
